Allans Vehicle Services

How to remove the sleeping compartment from a Mazda Bongo.

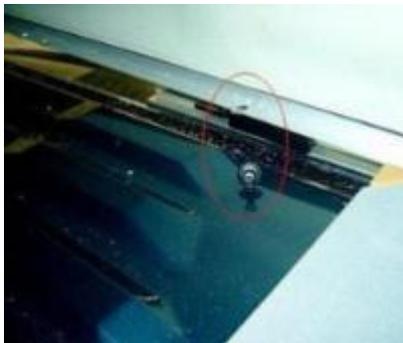
1. Raise the roof 3/4 way up.
The fabric is attached to a metal frame.
The bottom of the frame is fixed to the vehicle body with black plastic screws. These may also be glued in.
2. Working from back to front, unscrew the bottom screws.

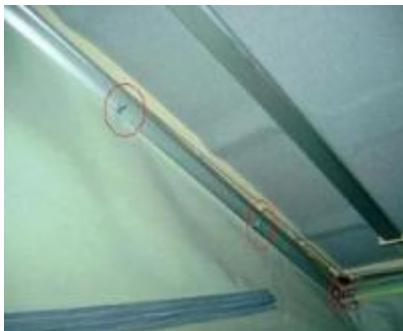
3. The top of the frame is attached to the hard roof by metal screws. They are tight.
Working from back to front, unscrew them.

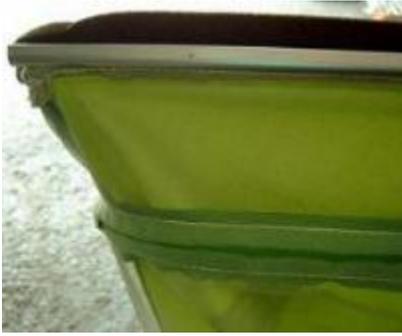
The fabric is slotted into metal runners which make up the top and bottom of the framework.

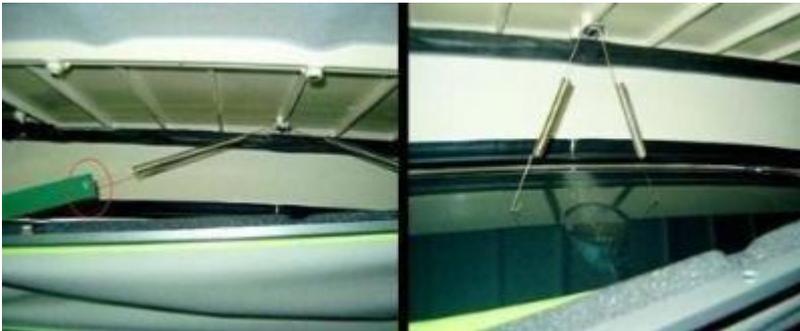
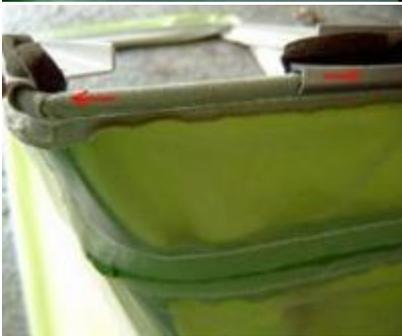
4. Pull the fabric left & right in the direction of the arrows, to slide the fabric out of the frame. This can be tight, silicone lubricant may help with removal.

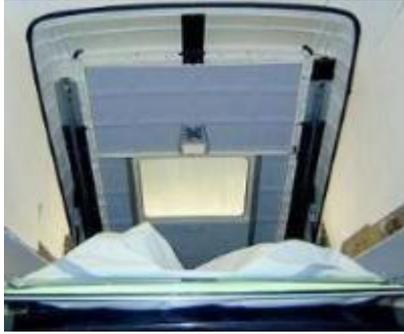
5. There are two springs at the rear of the compartment, attached top and bottom, from the hard roof to fabric straps. Unclip the springs from the fabric straps, leaving the springs dangling from the roof.

6. The metal framework with fabric will now drop down from the hard top and is ready to remove. It's not heavy but it's difficult to keep steady. To avoid damage, get help to lift it.
